# Characterization, Analysis, and Investigation of the Provenance of the Stone Construction Materials of the Vera Cruz Church (Segovia, Spain)

**Abstract:** As part of the restoration project of the 13th century Vera Cruz Church (Segovia, Spain), a preliminary study of the stones used in its construction—dolostones of the Montejo de la Vega Fm of Santonian age (Upper Cretaceous)—and the possible location of the quarry of the provenance of these stones was carried out. For this purpose, a comparative analysis was performed between the currently active quarry of La Vera Cruz n° 88 and the historical quarry of Zamarramala. The samples were characterized using a multidisciplinary approach, combining X-ray diffraction (XRD), polarized optical microscopy (POM), and scanning electron microscopy with microanalysis (SEM-EDX). The combined mineralogical, chemical, and textural characterization provided valuable information on historical provenance. The results show a significant correlation between the dolostone samples obtained from the church and both quarries. The integral characterization confirms the suitability of the dolostones identified in the currently active quarry, Vera Cruz n°

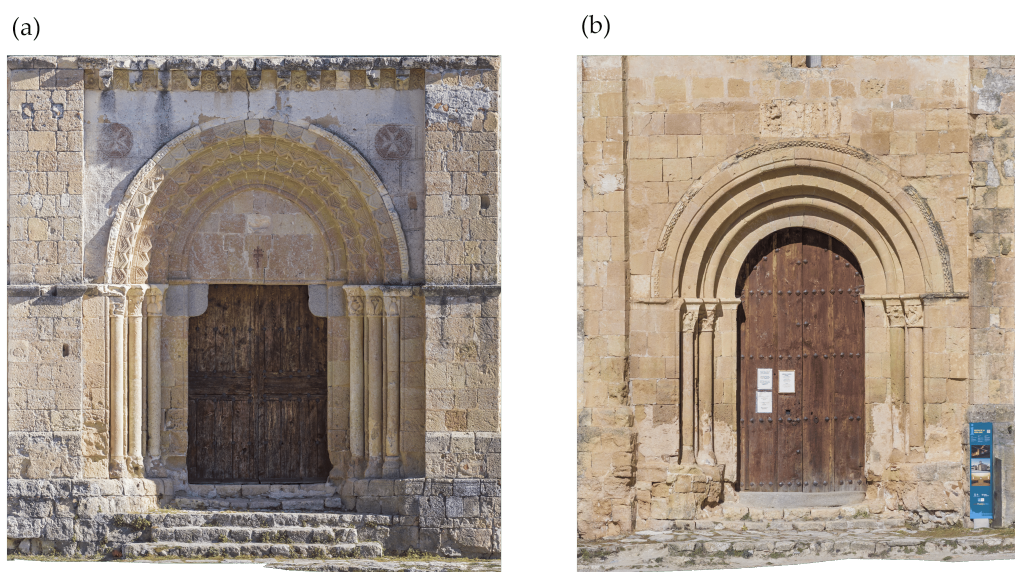
**Figure 2.** Church façades: (a) West doorway; (b) South doorway. Orthoimages: Luis-Javier Sánchez-Aparicio.

The south doorway (Figure 2b) is also flared but has only two pairs of semicircular archivolts. These are surmounted by a chequer molding as well. In this doorway, the work on the archivolts and capitals is simpler and the decoration is much less elaborate. Above this door is a bas-relief that was described in the report of the Royal Academy of Fine Arts of San Fernando. It had already deteriorated in 1919, but it was possible to identify a seated monarch or a judge in the act of administering justice on the left side, three standing women on the right, and a tree in the center [4]. This bas-relief is currently in a very advanced

state of deterioration (see also Section 1.4 Stone Weathering), which makes it impossible to recognize the iconography described in the report by the San Fernando Royal Academy of Fine Arts for the declaration of a “National Monument” in 1919.

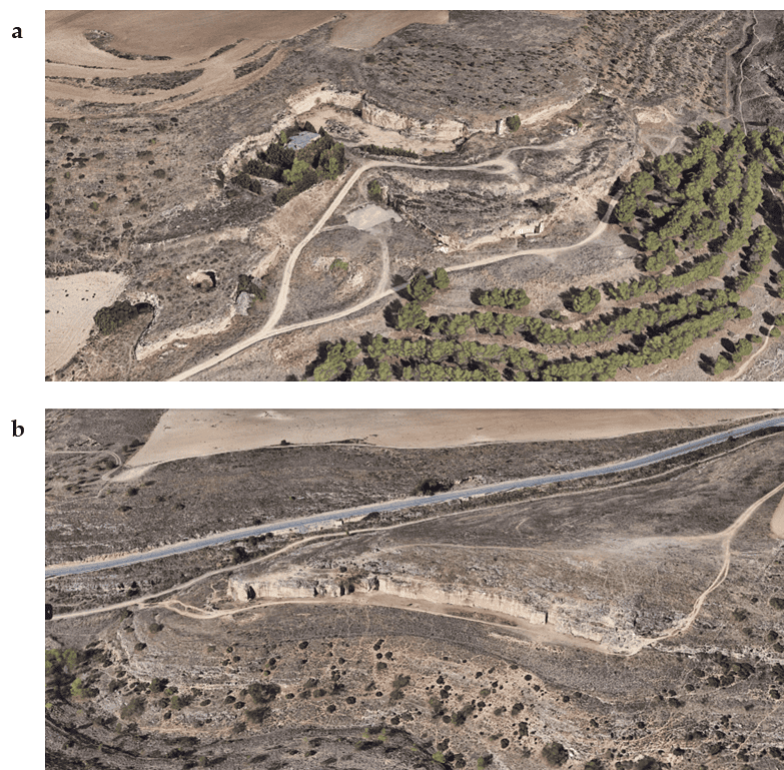
Parral dolostone is quarried at ‘Vera Cruz n° 88’ (Figure 4a), which is still active today, and could be used for the reconstruction of elements in the church. It is an open-cast quarry, although there are traces of underground mining. The terraces are about 10 m high on a slope front about 100 m long [24]. The stone, soft and porous, is suitable for building (Table 1). It is possible that the stones in Vera Cruz come from different strata and quarry faces.

As for the Zamarramala quarry (Figure 4b), it is also an open-cast quarry with traces of underground extraction and with better-quality fronts [24]. It was exploited in search of a stone with a finer grain size and lighter color, considered to be of better quality for carving.

**Figure 4.** (a) Active quarry of Vera Cruz n° 88. (b) Historical quarry of Zamarramala. Source: Google Earth [34].

Stones from the Vera Cruz n° 88 quarry, the characteristics of which were studied in VC-01, would be suitable for the restoration efforts within the Vera Cruz Church.

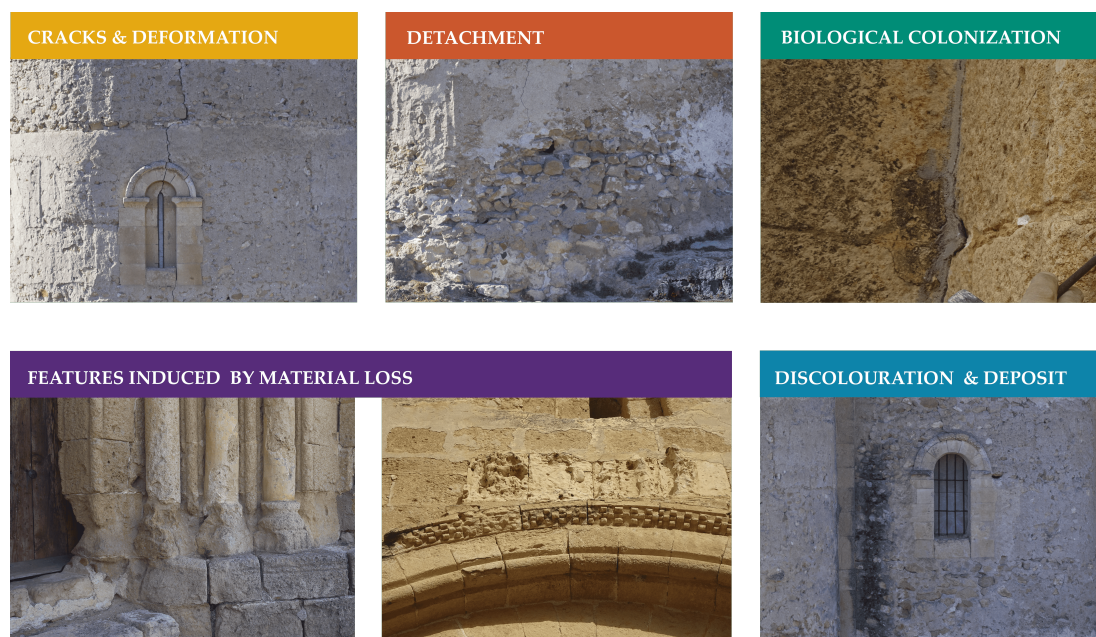
Following the terminology proposed by ICOMOS [35], alterations are identified in all the categories described in the Glossary, as visually illustrated in Figure 5.

Fracture-type cracks are observed in the masonry and are particularly evident in the apses (west façade) and interior vaults. As a result of the accumulation of water and unfortunate interventions, detachments in the form of fragmentation can be seen in the base area and in the masonry.

The predominant alteration observed in the monument is material loss. There is pitting (unconnected cavities) in the contact zones between the granite steps and the dolostone on the south façade [22]. In addition, interconnected cavities in the form of alveolization are prevalent. Discoloration and deposits associated with damp conditions are particularly concentrated on the base and roof, giving rise to efflorescence and soiling.

Biological colonization of spores within dolostone pores causes cracking upon germination. Low intracrystalline porosity potentially hinders fungal penetration into the crystal, so they are located in spaces between dolomitic crystals. Fungi are predominantly associated with altered zones, both on the surface and in the interior [31]. In addition, plants are also found on the outer walls.

**Figure 5.** Stone weathering following ICOMOS terminology.

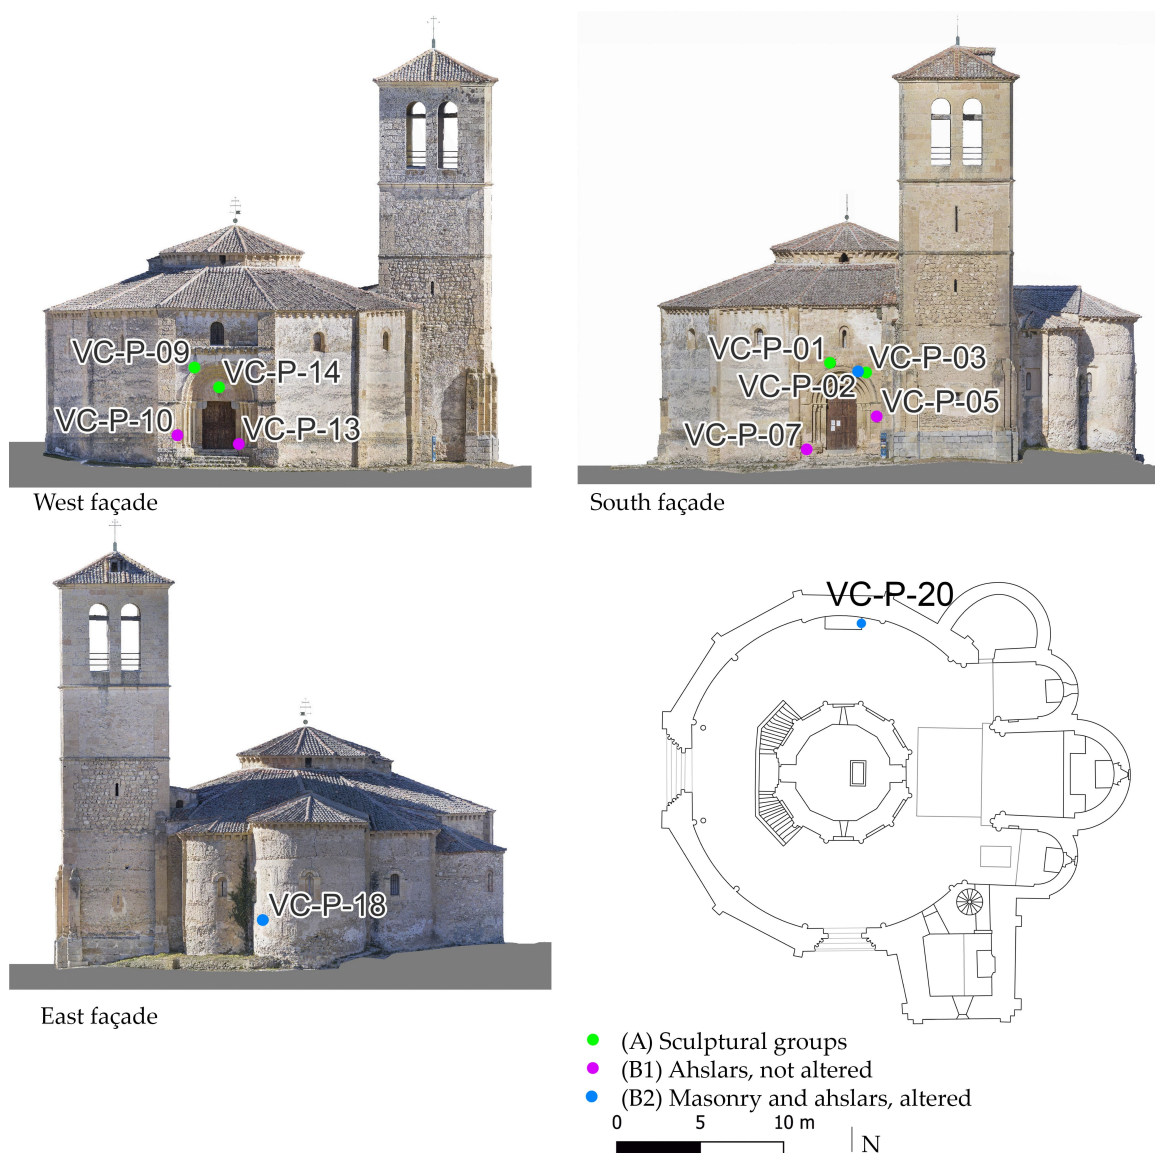
Ten samples were taken from the outside of the church (Figure 6) (east façade: VC-P-18; south façade: VC-P-1; VC-P-2; VC-P-3; VC-P-5; and VC-P-7; and west façade: VC-P-9; VC-P-10; VC-P-13; and VC-P-14) and one from the interior (VC-P-20) in the altar area. These samples were extracted and analyzed, in accordance with the principles of minimum intervention and maximum conservation of the original materials, following the characterization sequences recommended by the ICOMOS Natural Stone Committees [35].

**Figure 6.** Location of samples in the outside of the building. East façade: VC-P-18 (Apse). South façade: VC-P-1 (sculptural ensemble on the door); VC-P-2 (decorations on the door); VC-P-3 (ashlar facing above the door); VC-P-5 (Impost); and VC-P-7 (Baseboard). West façade: VC-P-09 (decorations above the door); VC-P-10 (Ashlar on the baseboard); VC-P-13 (inner part of the ashlar on the baseboard); and VC-P-14 (Sculptural ensemble in the door). Interior: VC-P-20 (Altar). Orthoimages: Luis-Javier Sánchez-Aparicio. Layout: Diego Vicente Sánchez.

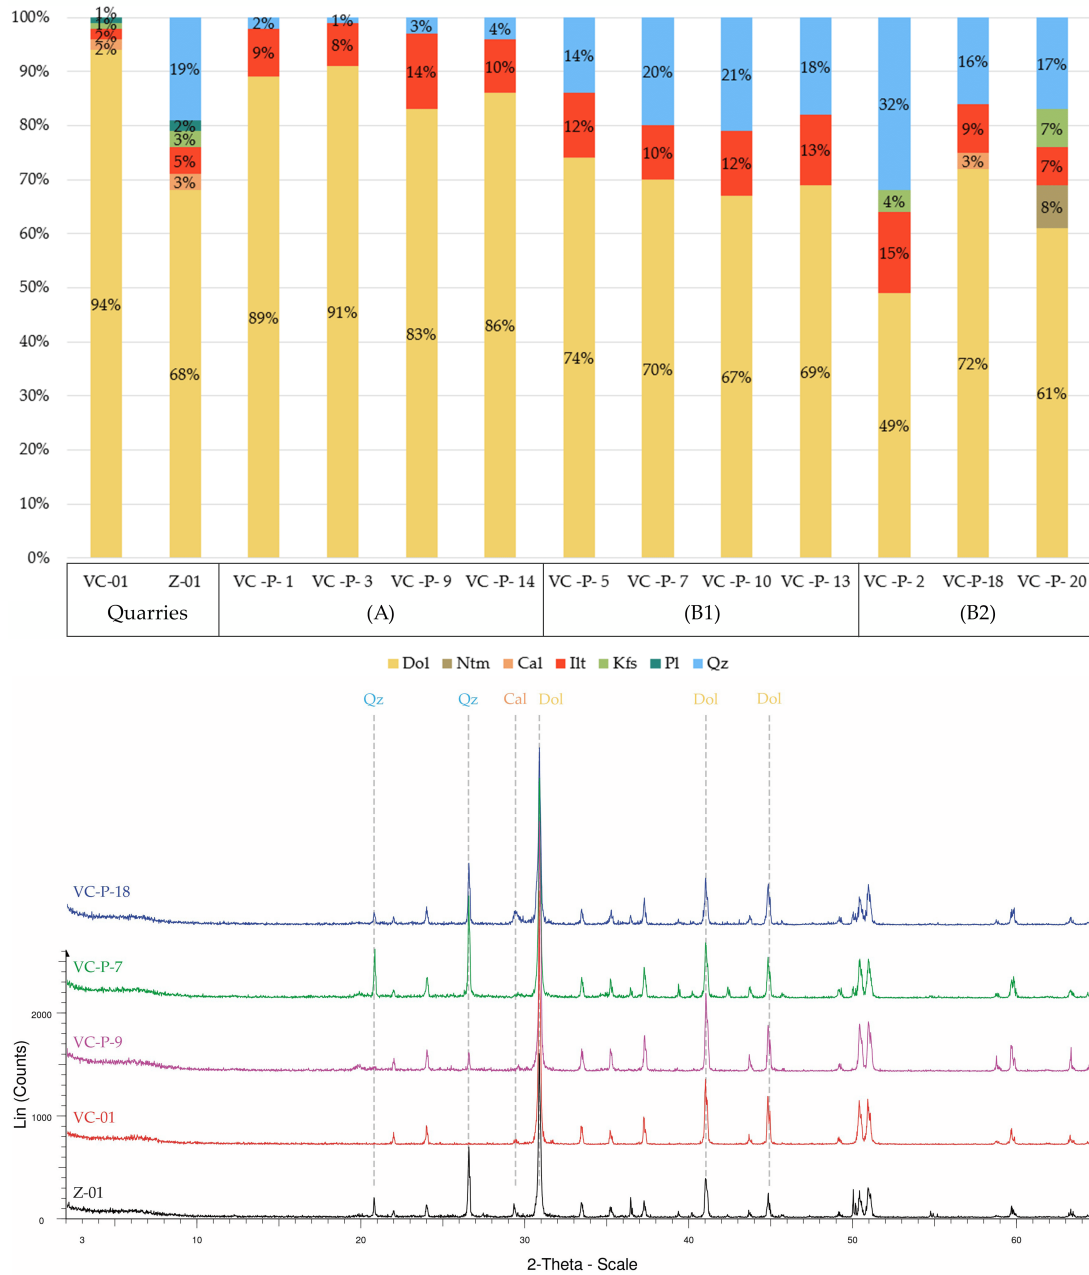
All samples have dolomite as the predominant crystalline phase, with percentages ranging from 49% to 91% in the church samples, 94% in the Vera Cruz quarry, and 68% in the Zamarramala quarry, with smaller proportions of quartz and clay minerals. All of them are classified as dolostones.

The dolostones from the nearby quarries differ in composition. For example, the sample from the active quarry of Vera Cruz is a dolostone of high purity (94%), with no quartz detectable by XRD, and with clay minerals, potassium feldspar, plagioclase, and calcite in proportions of less than 2%. The sample from the historical quarry of Zamarramala has a significantly lower dolomite content of 69%. It has 19% quartz and, as in the previous case, has the same accessory minerals in slightly higher percentages, up to 5%.

Based on their quartz content, the samples from the church are categorized into two groups. The first group (A) includes samples with a lower percentage of quartz (1%–4%), consisting of VC-P-1, VC-P-3, VC-P-9, and VC-P-14. These samples were taken from sculptural groups on the façade (see Figure 6).

The second group (B), made up of the remaining samples, has a quartz content from about 15% to 30%. These correspond to those taken from the ashlar. According to the sampling location and their visually appreciated decay, two different subgroups are established. The first subgroup (B1) includes stones taken from the upper parts, where there is minimum or no water accumulation, showing good conditions. These are VC-P-5, VC-P-7, VC-P-10, and VC-P-13. The second subgroup (B2) comprises samples taken from lower areas that are exposed to the effects of wind and water accumulation. VC-P-2, VC-P-18, and VC-P-20 show a higher degree of weathering.

**Figure 7.** Mineralogical identification and quantification in %. XDR patterns of quarries and diffractogram of representative samples with identification of the principal peak phases. Abbreviations after Whitney and Evans [38] and Cardell Fernández [39]: Dol (Dolomite), Cal (Calcite), Ilt (Clay Minerals/Illite), Kfs (Potassium feldspar), Pl (Plagioclase), Qz (Quartz), Ntm (Nitromagnesite).

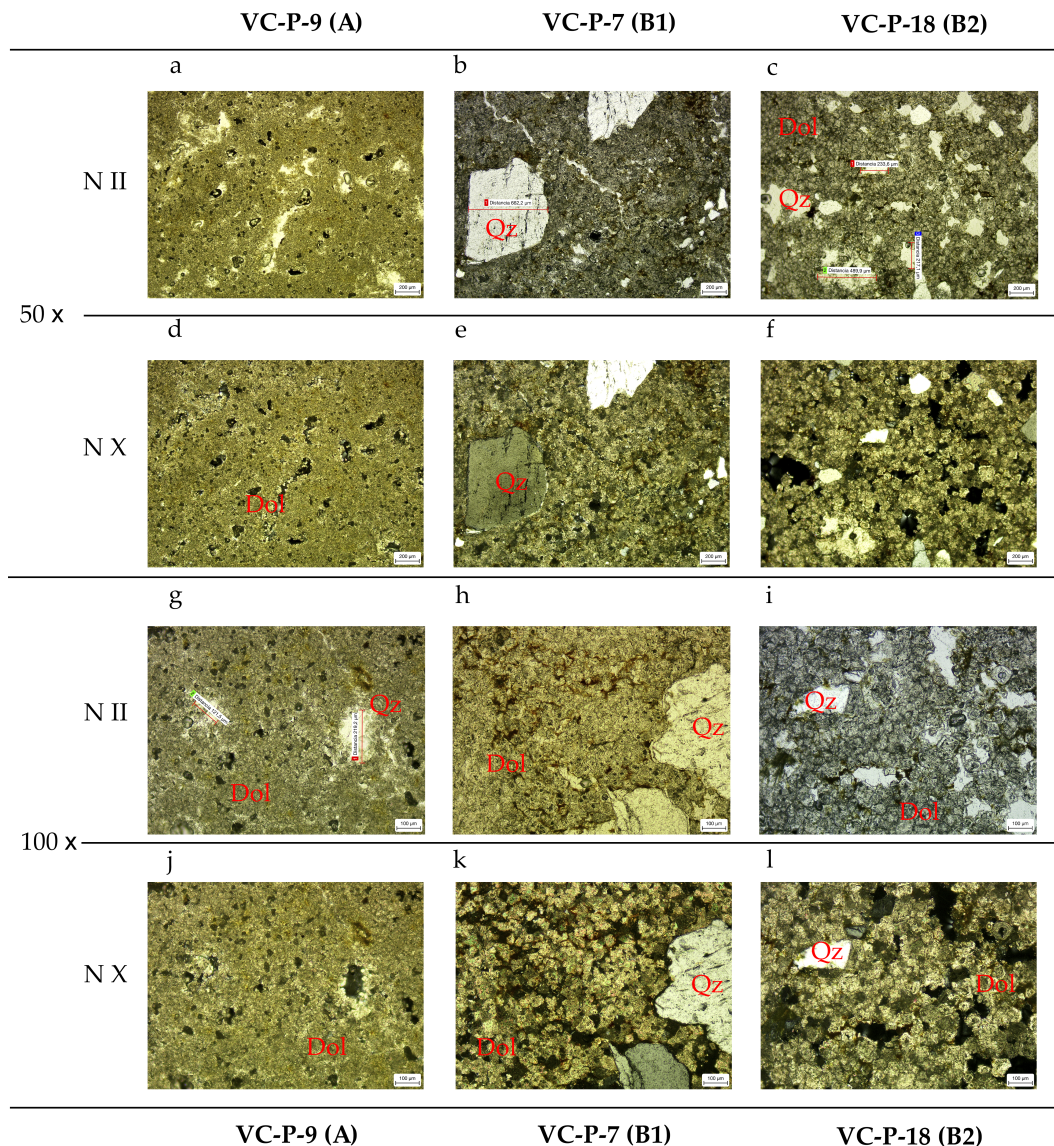
As the representative sample of Group A (Figure 10a,d,g,j), VC-P-9 is characterized by POM. Homogeneity and lack of interconnected porosity, with pore sizes of approximately 50  $\mu\text{m}$ , were observed. The absence of quartz is obvious. The dolomite grains have an irregular, fine-grained morphology. SEM-EDX (Figure 11a,d) shows a closed porosity. Well-formed dolomite crystals are observed, as well as recrystallized dolomite. Surface alteration is minimal. EDX analysis indicates the presence of calcium, magnesium, carbon, oxygen, and iron, interpreted as dolomite and iron products of weathering.

**Figure 10.** Thin section of the church's samples: (a) VC-P-09 (Group A), 50 $\times$  magnification parallel nicols; (b) VC-P-07 (Group B), 50 $\times$  magnification parallel nicols; (c) VC-P-18 (Group C), 50 $\times$  magnification parallel nicols; (d) VC-P-09 (Group A), 50 $\times$  magnification crossed nicols; (e) VC-P-07 (Group B), 50 $\times$  magnification crossed nicols; (f) VC-P-18 (Group C), 50 $\times$  magnification crossed nicols; (g) VC-P-09 (Group A), 100 $\times$  magnification parallel nicols; (h) VC-P-07 (Group B), 100 $\times$  magnification parallel nicols; (i) VC-P-18 (Group C), 100 $\times$  magnification parallel nicols; (j) VC-P-09 (Group A), 100 $\times$  magnification crossed nicols; (k) VC-P-07 (Group B), 100 $\times$  magnification crossed nicols; and (l) VC-P-18 (Group C), 100 $\times$  magnification crossed nicols.

In VC-P-7, from Group B1 (Figure 10b,e,h,k), two different sizes of quartz crystals are observed by optical microscopy. The larger ones measure approximately 600  $\mu\text{m}$ , while the smaller ones measure 100  $\mu\text{m}$ , both exhibiting subhedral morphology. In addition, recrystallization of dolomite about 70  $\mu\text{m}$  in size is observed (Figure 10k). Brownish oxides are presented in the matrix, indicating the weathering of the sample. Two distinct grain textures, one finer and the other larger, are identified by SEM images (Figure 11b,e). The surface texture of altered dolomite crystals shows high porosity and disintegration of the grain matrix, indicative of biological alteration. EDX analyses confirm the presence of clays and dolomite, as well as all the minerals detected by XRD.

VC-P-18, representative of Group B2 (Figure 10c,f,i,l), shows both anhedral and subhedral quartz crystals, measuring around 300  $\mu\text{m}$ , displaying undulating extinction. The dolomite matrix shows a variety of textures and sizes, with recrystallized dolomite. Pronounced intercrystalline and interconnected porosity is evident, accompanied by intracrystalline fungal attack. This sample stands out as the most substantially altered sample examined by POM. In Figure 11c,f, by SEM, the texture appears altered with loose and detached grains in the matrix, resulting in high porosity. Observations include biological alterations on the crystals, disaggregation, and poor adhesion to the matrix. EDX analysis confirms the presence of minerals identified by XRD (quartz, dolomite, and clay), together with biological alteration and iron-related smooth weathering processes.

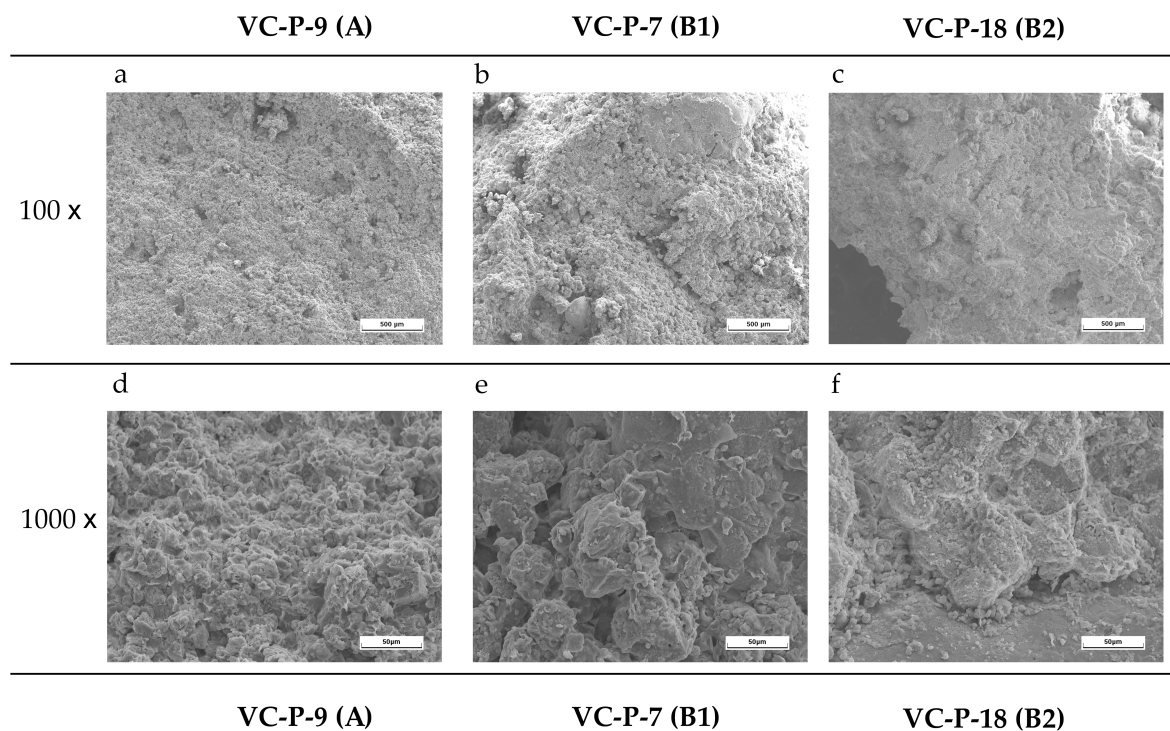
**Figure 11.** Electron microscopy images, secondary electrons at 20 kV. (a) VC-P-09, 100 $\times$  magnification; (b) VC-P-07, 100 $\times$  magnification; (c) VC-P-18, 100 $\times$  magnification; (d) VC-P-09, 1000 $\times$  magnification; (e) VC-P-07, 1000 $\times$  magnification; (f) VC-P-18, 1000 $\times$  magnification.
