# Catastrophic Wear of Tibial Component of Total Knee Replacement Due to Neglected Dislocation of Polyethylene Insert: A Case Report

Case Report

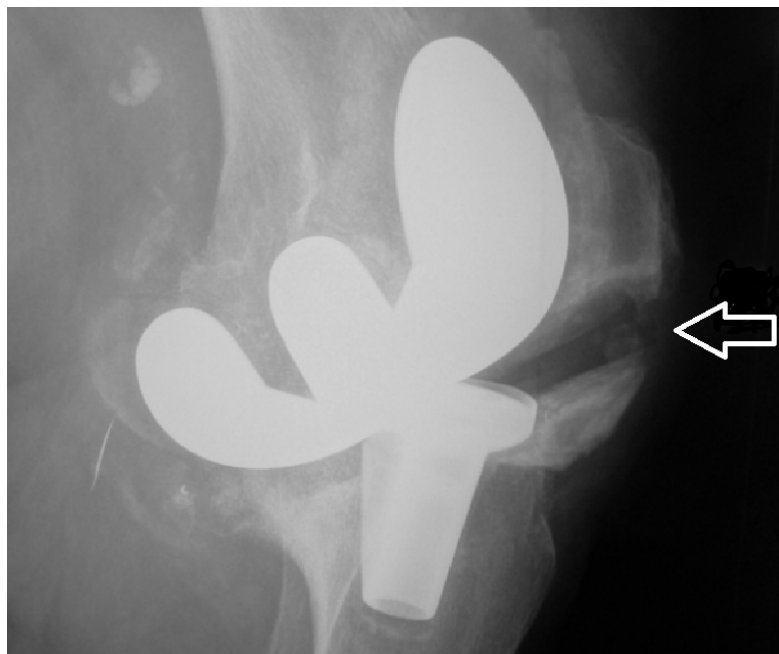
**Fig. 2. Oblique radiograph shows dislocated polyethylene insert lying beneath the patella**

On the plain radiographs, there was a loss of posteromedial tibial component, implant breakage on its lateral edge, loosening particularly in the tibial component, bone defect in the metaphyseal area of the medial tibial plateau, minimal replacement toward the posterior end in the femoral component, and free bone fragments on the posterior and anterior of the femoral component. The insert was seen in the form of a silhouette on the anteriolateral portion of the knee joint (Figs. 1 and 2).

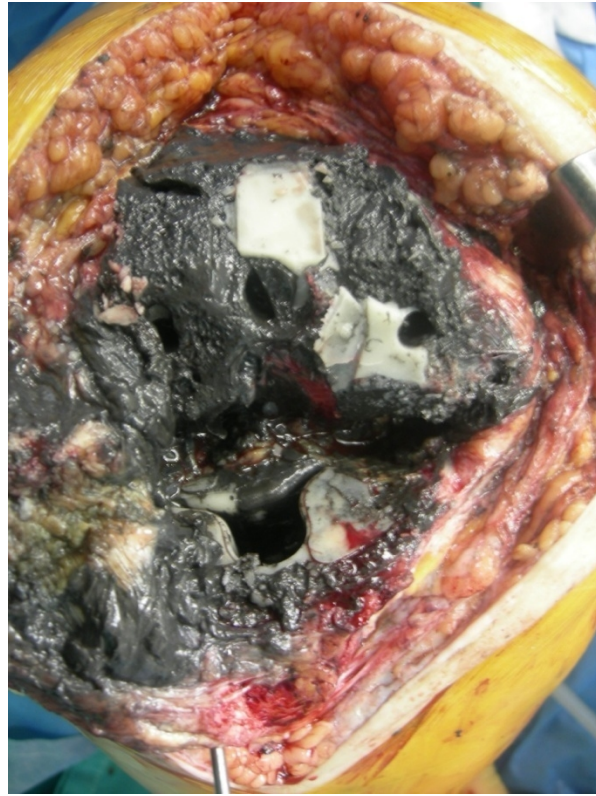
**Fig. 3. The intraoperative appearance of foreign body reaction (sludging) in the osseous tissue**

The patient was subjected to revision surgery in the right knee under spinal anesthesia. Polyethylene insert was found under the patellar tendon. The corroded and broken implant parts were removed. The posterior cruciate ligament (PCL) had lost its unity, but the collateral ligaments were intact. In the entire intra-articular soft tissue, particularly in the synovial tissue, marked sludging by excessive metallosis was observed. The pigmented foreign body reaction tissue and wide-spread osseous pigmentation were also found (Figs. 3, 4 and 5). The materials were examined by Department of Pathology.

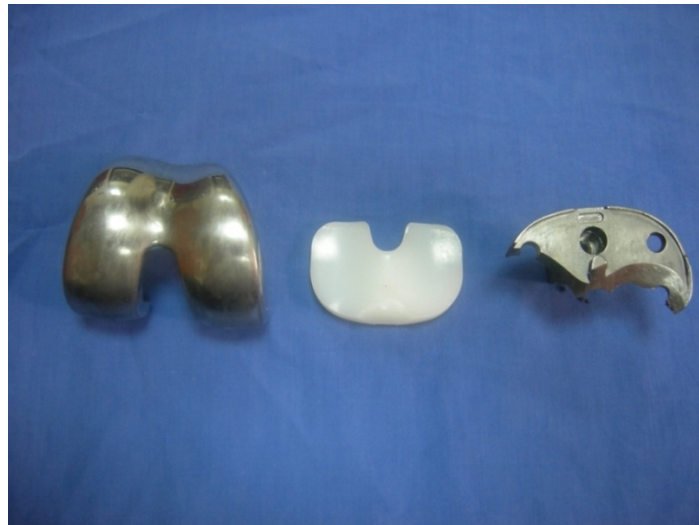
**Fig. 4. The appearance of defect at the tibial component and an intact polyethylene insert**
